## Monitoring Data Record

Project Title: R-2809B (Site 1) COE Action ID: 199601836
Stream Name: <u>UT to Richland Creek</u> DWQ Numbers: <u>010550</u>
City, County and other Location Information: Wake Forest Bypass, Wake Co. (Left of Y2
Sta. 10+40 to Sta. 11+25)
Date Construction Completed: April 2006 Monitoring Quarter: (1) of 4
Ecoregion: 8 digit HUC unit: 03020201
USGS Quad Name and Coordinates:
Rosgen Classification:
Length of Project: 384' Urban or Rural: Rural Watershed Size:
Monitoring DATA collected by: M. Green Date: 5/10/06
Applicant Information:
Name: NCDOT Roadside Environmental Unit
Address: 1425 Rock Quarry Rd. Raleigh, NC 27610
Telephone Number: (919) 861-3772 Email address:
Consultant Information:
Name:
Address:
Telephone Number: Email address:
Project Status: Complete

## Wake Forest Bypass

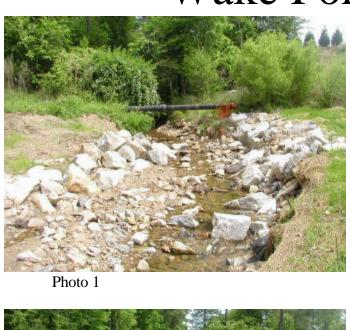
Date	Station	Station	Station	Station	Station
Inspected	Number	Number	Number	Number	Number
Structure	Photo 1	Photo 5	Photo 5	Photo 6	
Type	Left Bank	Right Bank	Crossvane	Left Bank	
Is water					
piping					
through or					
around					
structure?					
Head cut or					
down cut					
present?					
Bank or scour	Yes	Yes		Yes	
erosion					
present?					
Other			Erosion		
problems			behind right		
noted?			arm of		
			crossvane
